Contract #: 04-0120F4Cty: SF/ALA Rte: 80 PM: 13.2/13.9File #: 1.28**WELDING INSPECTION REPORT****Resident Engineer:** Casey, William**Address:** 333 Burma Road**City:** Oakland, CA 94607**Report No:** WIR-026984**Date Inspected:** 03-Jan-2012**Project Name:** SAS Superstructure**OSM Arrival Time:** 700**Prime Contractor:** American Bridge/Fluor Enterprises, a JV**OSM Departure Time:** 1530**Contractor:** American Bridge/Fluor Enterprises, a JV**Location:** Job Site**CWI Name:** See below**CWI Present:** Yes No**Inspected CWI report:** Yes No N/A**Rod Oven in Use:** Yes No N/A**Electrode to specification:** Yes No N/A**Weld Procedures Followed:** Yes No N/A**Qualified Welders:** Yes No N/A**Verified Joint Fit-up:** Yes No N/A**Approved Drawings:** Yes No N/A**Approved WPS:** Yes No N/A**Delayed / Cancelled:** Yes No N/A**Bridge No:** 34-0006**Component:** SAS**Summary of Items Observed:**

WELDING INSPECTION REPORT

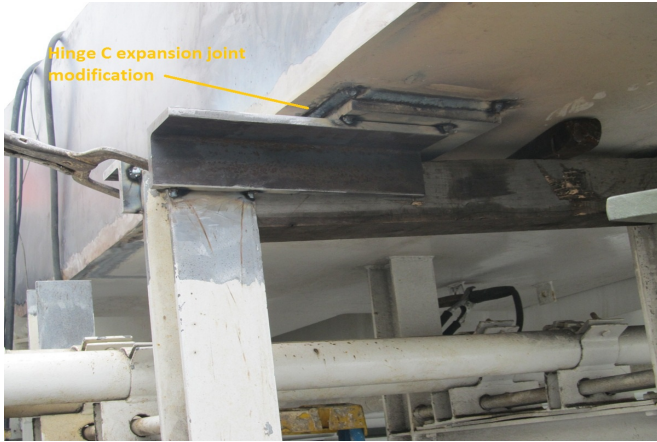
The QA Inspector noted the welding was nearly completed at the above identified location upon the arrival of the QA Inspector in the AM. The QA Inspector noted the welding was completed by lunch time on this date. The QA Inspector randomly observed the QC Inspector perform visual testing of the completed welds for the modification of the above identified expansion joint. The QA Inspector noted the QC Inspector indicated the welds were acceptable after completion of the inspection. The QA Inspector performed a random visual and dimensional inspection of the completed fabrication and noted the welding was completed with satisfactory results.

The QA Inspector noted the painting contractor has moved in to begin coating the recently welded and installed material. The QA inspector observed the welding contractor begin moving the equipment down to the expansion joint B to begin demolition and fabrication of the PS-19 MODS.
